## At the Repair Bench – Antenna Rotator Controller – December 2023

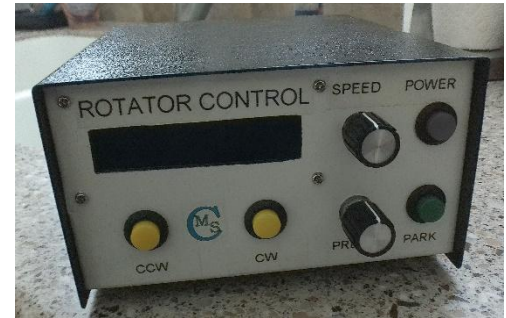
Figure 1 - Antenna rotator controller

This controller consists of some very basic parts... (1) an H-bridge motor driver to handle the output current to the rotator motor, including directional (polarity) control, (2) a simple five-volt voltage regulator that drops the incoming 24VDC down to the 5VDC required by the brains of the unit, and (3) an Arduino Mega2560 microprocessor board. A plain Mega2560 shield was built up to bring out the necessary pin connections as well as serve as the PCB for a low-pass filter that is a crucial part of the circuit.

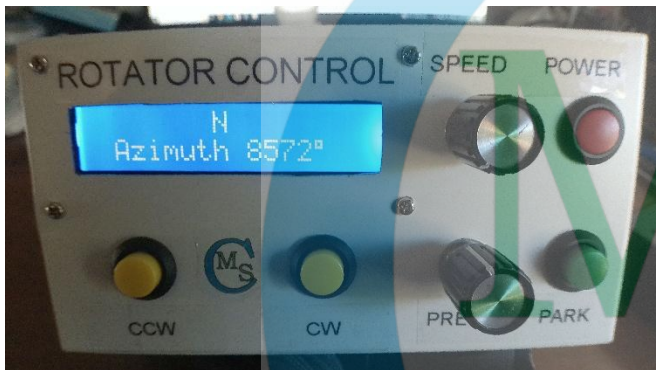
Back around the end of May, Al KB2AYU came to me and told me that the antenna rotator controller (Figure 1) that I had built and given to the club for use in the VHF room was “hosed”. A quick look at it showed that he was correct – the display, which should have been showing azimuthal readings between zero degrees and three hundred and sixty degrees, was displaying values way up into the four- and five-digit area (Figure 2), as well as blanking out some of the letters in the word “Azimuth”, which should have been displayed as well.

Figure 2 - Erroneous display on controller

Knowing that the programming had already been uploaded to the Arduino once since this problem began, and also knowing that the upload did not resolve the issue, I was left with the base Arduino as the fault source. Now... the Arduino obviously operated, as it was sending data to the H-bridge and the display, even if that data was incorrect. My reasoning told me to try to recover the Arduino and restore its proper operation.

There is a piece of software embedded on the Arduino called the *bootloader* which basically sets up the operating condition of the Arduino in use. That is the only thing, apart from a possible hardware failure, that determines how the Arduino behaves. Because of the fact that this is a piece of embedded software, the possibility exists that this software could have become corrupted. I decided to erase the Arduino and to burn a new bootloader into place on the board.

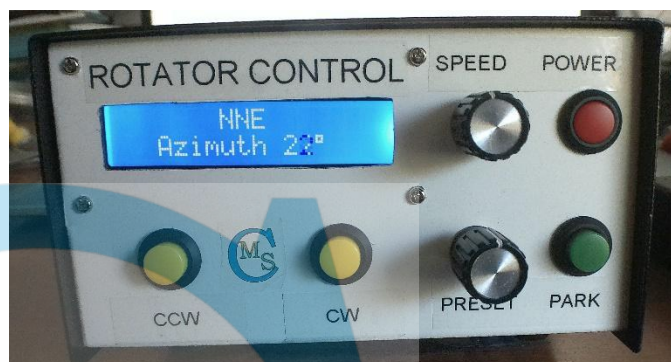
I did all of this, and then I re-uploaded the operational program to the Arduino again. Next, I completely re-assembled the controller (without its cover), including installing the shield board and re-connecting all of the pin connections. Finally, I connected up the 24VDC power supply to the controller and turned it on. *Voilà!* It worked normally, as it should have done. Note that the “damaged” digit in the Figure 4 image is a digit that was in the process of changing when the photo was snapped.

Figure 4 - Fully operational rotator controller

Finally, I installed the top cover, and the job was complete. I connected it up to a Yaesu rotator unit that I have on hand here, and it worked flawlessly. Thus, it was able to go back to the clubhouse that evening.
